Restoration of a Skeleton National Telephone Company N° 16

After buying the UK version of this classic early 1900 LM Ericsson table phone, and realising that it was in a very poor state it has taken some years to get the time and motivation to tackle the job.

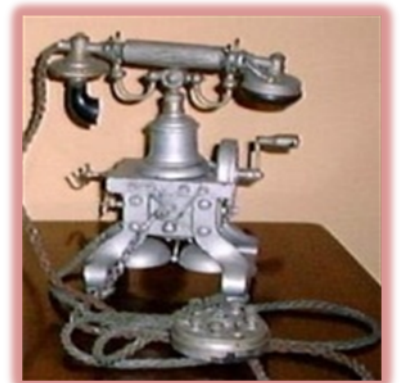
- Quite a large piece broken from the side of the turret - a simple repair using "Plastibond" for strength.

- **Different timber turret**
 - To a casual viewer, the turret looks the same as any other, but it is marginally bigger in diameter at the base where it fits to the deck. The breakage originated at two of the screw holes where the turret is fixed to the deck. This could have been caused by lifting or carrying the phone by the turret or handset cradle - a definite "NO/NO".

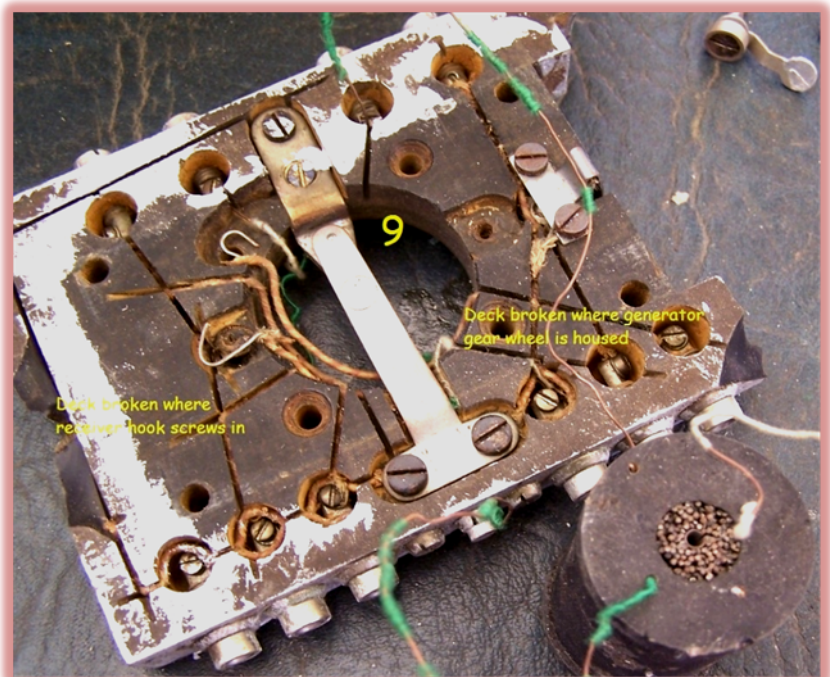
Before we start the repairs, remember to take plenty of pictures to aid in the re-assembly process. This picture of the deck wiring (underside) is a very good example of the value of pictures. Without it, it can be very difficult to correctly restore the circuitry of the induction coil and other components.

Although it may be difficult to see "what goes where" in this picture, we will find that with it in conjunction with the parts laid out on the bench, it can be just as straightforward as completing a jig-saw

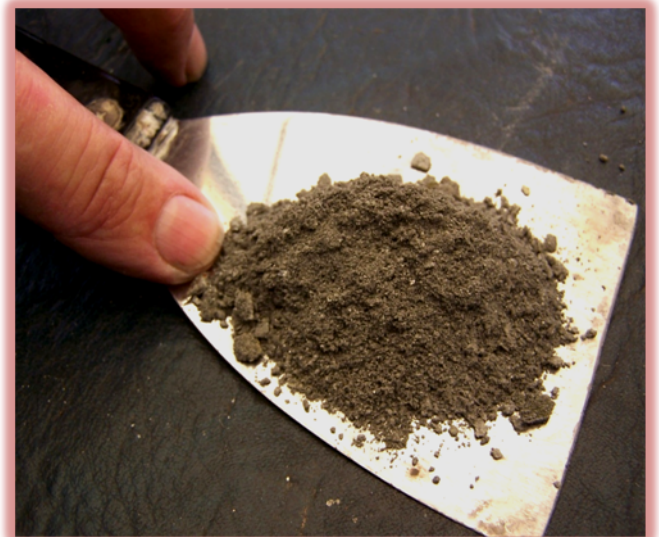
In the case of this particular telephone, a large part of the preparation of the parts was to first remove the thick handpainted Silverfrost. Surprisingly this paint was best removed using Methylated Spirits - this picture shows the amount of paint that was removed after all of the methylated spirits evaporated off - approximately 2 tablespoons.

After soaking in methylated spirits for about 1-2 hours, the paint was able to be lightly scrubbed off into the methylated spirits container. Use either fine steel wool or small stiff brush. Most of plated metal parts can be scrubbed more aggressively and the plating might still be left in a good condition.

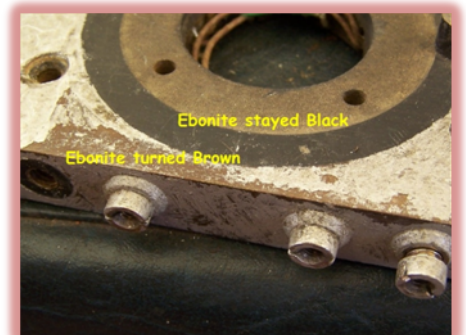
When the phone has been dismantled, the change of colour of the deck due to age and the environment can be clearly seen where the turret has covered and protected it from environmental conditions. There would be differing opinions regarding whether the deck colour should be returned to black, or to carefully retain the brown colour that it has turned to over almost 100 years of exposure to light and other conditions - the author believes that this is an important sign of age (patina) and should only be cleaned with the shine restored. For folk preferring black, the only realistic way is to apply gloss paint

To repair the breakages in the deck, reinforcing is mandatory - even with a "Plastibond" type of repair, it easily will break out unless reinforcing wire has been first. The deck should be buffed to a reasonable finish shine before the

breakages are repaired. Then drill small holes into the break(s) and glue in reinforcing wires using "5 minute" Araldite. To minimise any tidy up finishing work, use masking tape or in other ways, prevent excess Plastibond from flowing onto unwanted areas. In the case of this deck repair, a screw of the correct thread size with a liberal coating of petroleum jelly is inserted into the break, to create the required threaded hole. The petroleum jelly allows for an easy removal of the screw thread after the repair has hardened.

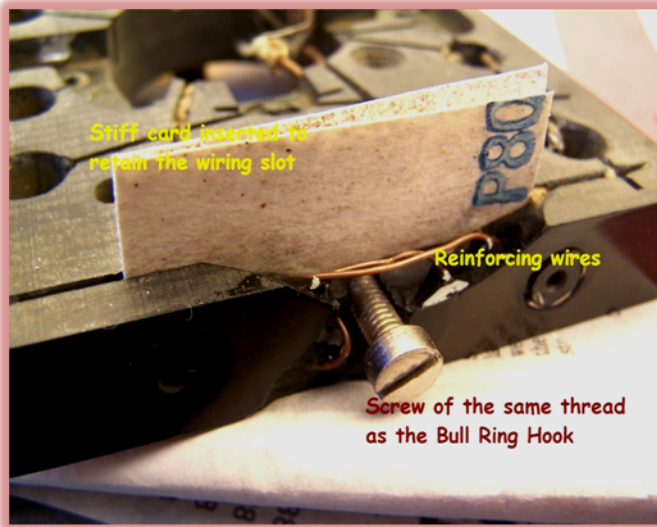
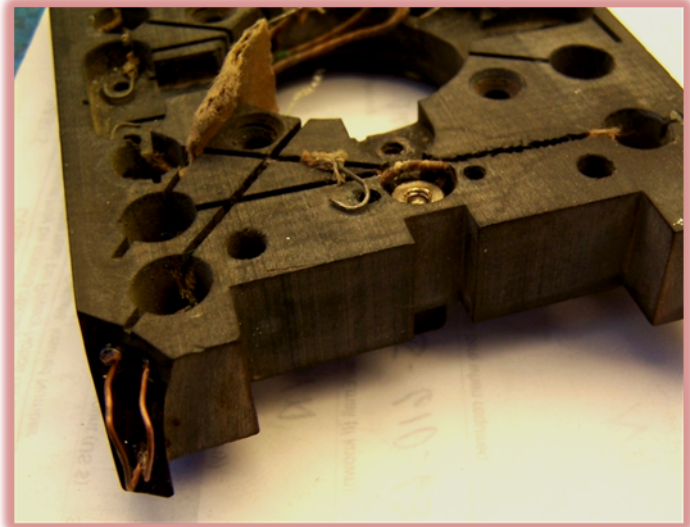
The following pictures show the deck in preparation for repair with with a precoloured "Plastibond" product

The right hand pictures also shows a small piece of cardboard wedged into a wiring slot to hold a loose wire in place. Before the hardener is added to the Plastibond it should be colour matched using tints as closely as possible to the aged colour of the deck.

A couple of coats of shellac will finish it off nicely when the repair to the deck is completed and and sanded to a smooth finish, and the colour match is satisfactory - this sentence doesn't take long to read, but there will be around a half day's work to actually achieve it.

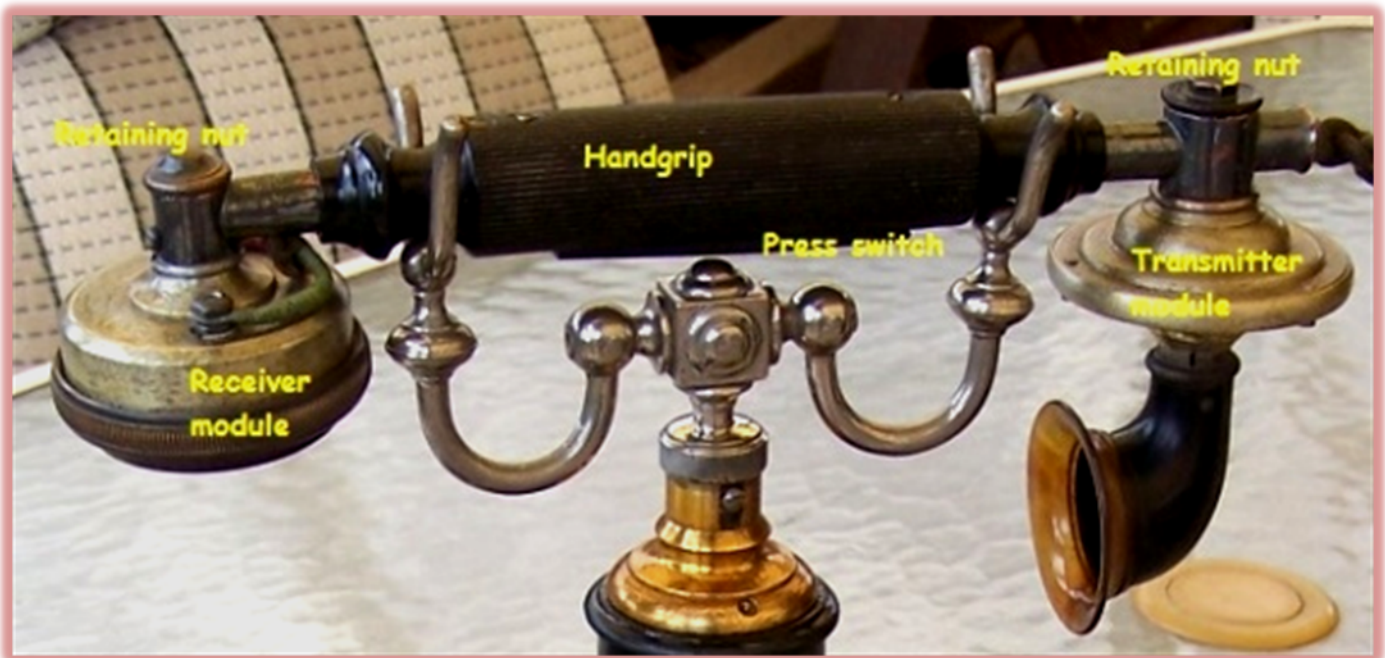
For this telephone, the handgrip had a minor breakage so it had to be dismantled.

Henry Ford would approve of this handset, the British (National Telephone Co) version with their typically drab finishes. Black plating of the metal parts such as the tubes housing the cord, and sometimes the receiver and transmitter modules. This one though has a less elegant alloy receiver and transmitter module. The rare tortoiseshell enhanced mouthpiece horn is not the original - these were only found on the Peel Connor

Repairs are then carried out using the same principles outlined for similar materials ie Bakelite, Nickel plating, brass etc. Reproduction parts are available for those common breakages of transmitter horn and handgrip. Caution is needed when reinserting the transmitter and receiver end tubes into the handgrip. If it is a tight fit, carefully file out the inside of the handgrip with a "rat tail" (round) file. This will reduce the risk of the Bakelite handgrip breaking due to excess pressure, where it narrows at its' ends.
